Arizona-Southern California Outages on September 8, 2011

Causes and Recommendations

Prepared by the Staffs of the
Federal Energy Regulatory Commission
and the
North American Electric Reliability Corporation

April 2012

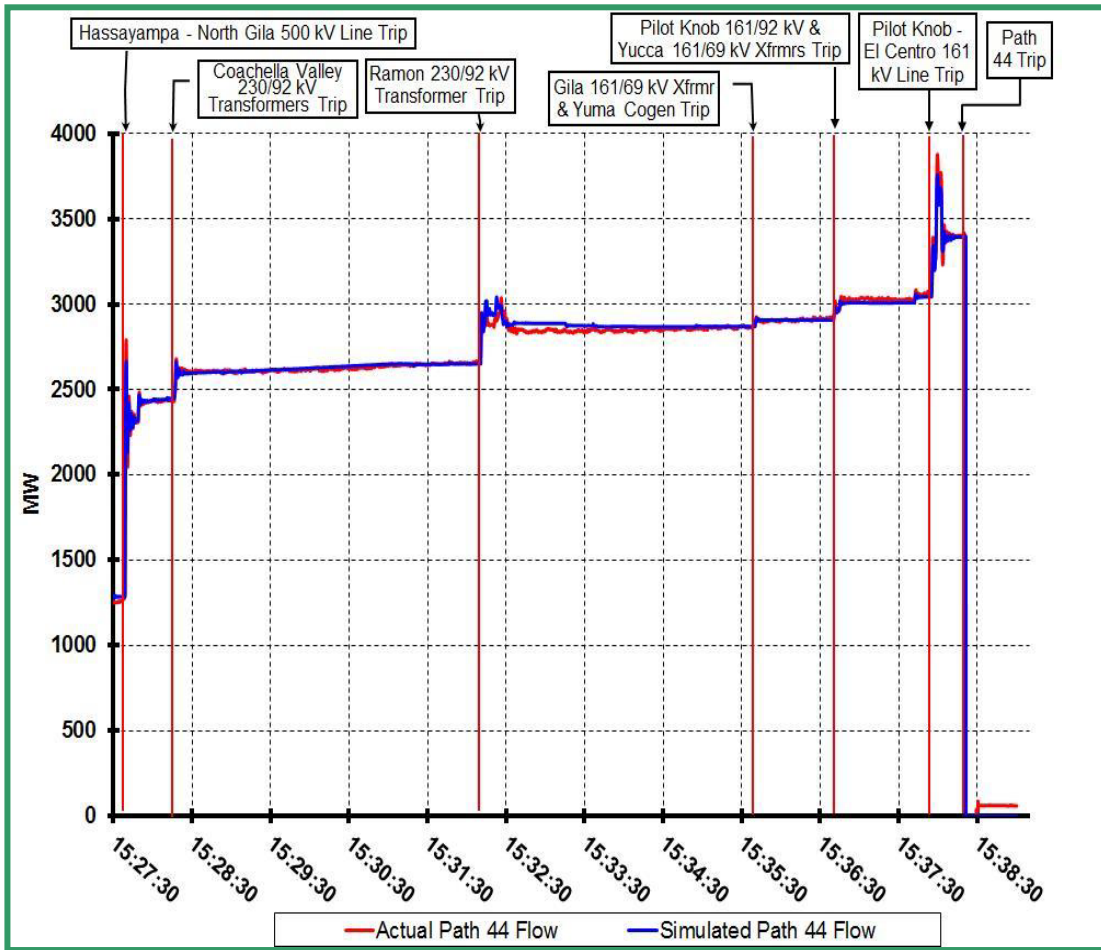
Figure 1: Comparison of Actual and Simulated Path 44 Flows

As the first step in performing power flow and dynamic stability analyses, the Modeling and Simulation team developed and benchmarked a modeling case of system conditions prior to the event. The team started with the WECC heavy summer base case and made adjustments based on State Estimator snapshots, EMS data, actual generation and schedules, PMU data, and a base case prepared by a separate team (led by CAISO) that studied the event. The team further adjusted and benchmarked the base case using SCADA and PMU data to match the system conditions for the entire event. The team devoted considerable time and effort to resolving discrepancies between the various sources of data to best calibrate the modeling case to actual measured data. As illustrated by **Figure 1**, on the next page, and described in more detail in Appendix D, the Modeling and Simulation team achieved a significant degree of accuracy. This figure compares Path 44 flows simulated by the Modeling and Simulation team to actual Path 44 PMU data.

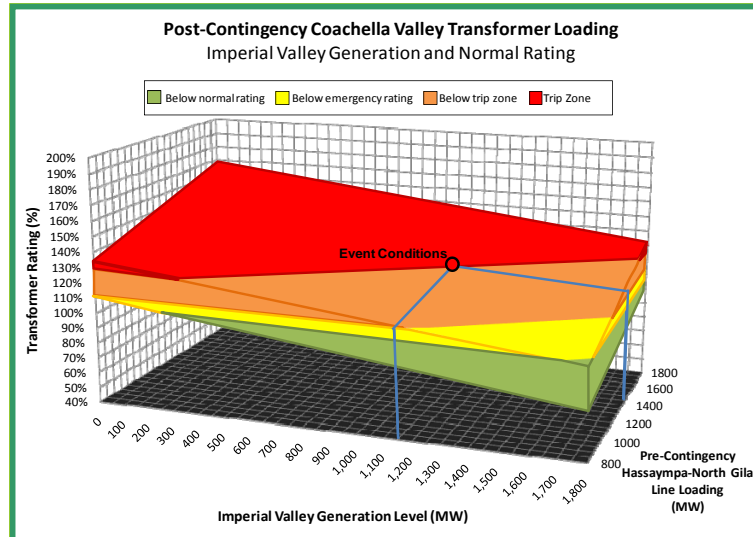
Figure 7 : Post-Contingency CV Transformer Loading Based on Imperial Valley Generation

In general, adding generation in San Diego, CFE, or Imperial Valley and backing down generation in APS's system (east of Path 49) would reduce the loading on IID's 92 kV system for the loss of H-NG. For example, an additional 600 MW of generation at Imperial Valley and a reduction of generation in APS's system by the same amount would have reduced the pre-contingency loading on H-NG by 20% and improved the post-contingency voltage in WALC's Blythe area by approximately 4%. Under this condition, the loading on the CV transformers for the loss of H-NG would be approximately 111% of their normal rating (166 MVA), well below their trip setting of 127%. This is a further demonstration of the importance of including all facilities when deriving SOLs.

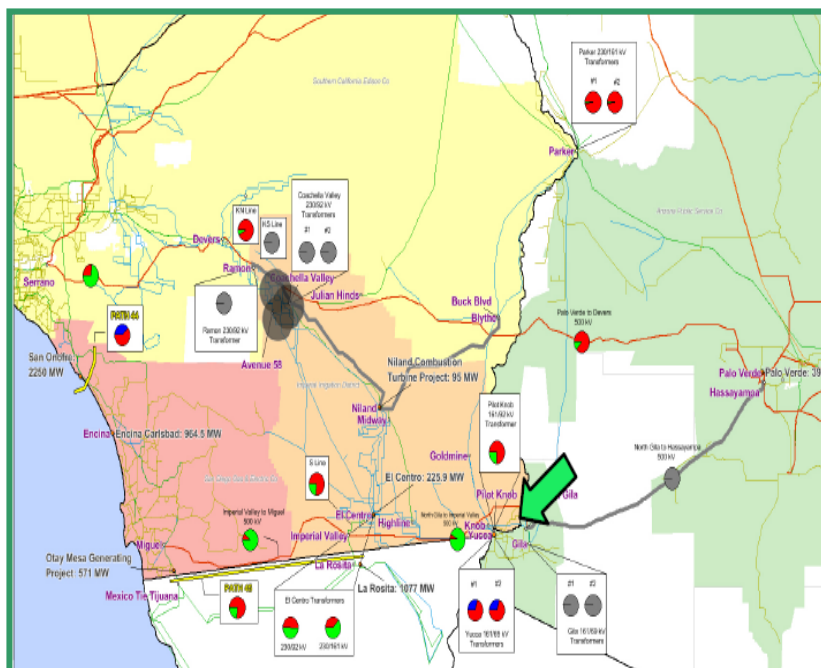
Time: 15:35:31 – Yuma Cogen (YCA) tripped. (180)

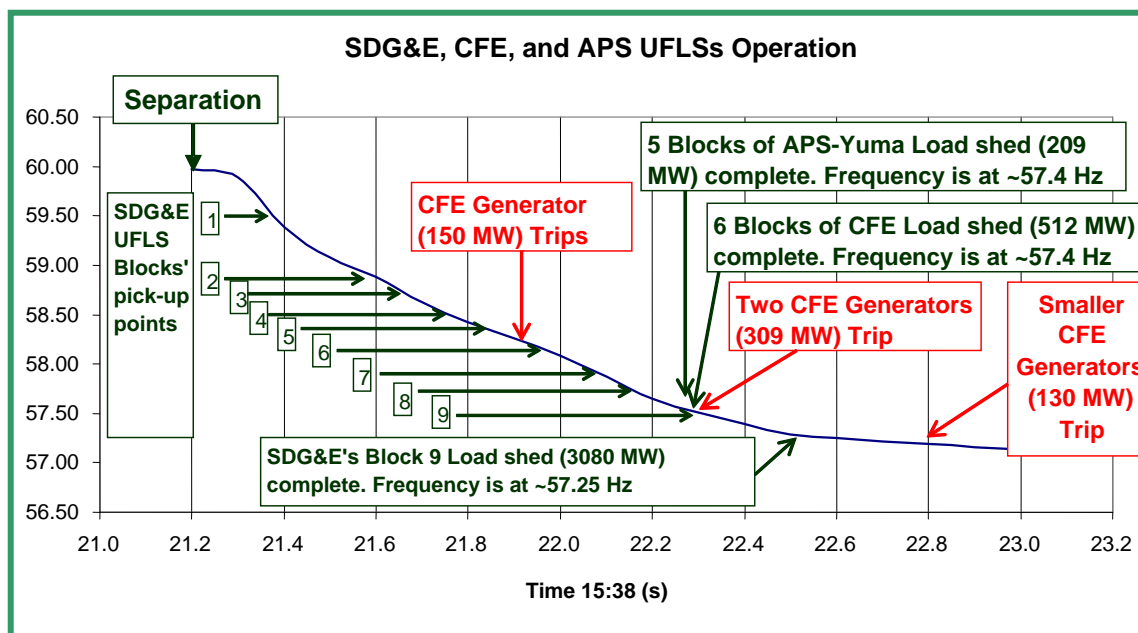
Figure 11: Frequency Performance in the SDG&E/Yuma/CFE Island

The CFE island separated from SDG&E after their only two remaining ties tripped in rapid succession. At 15:38:22.2, the Otay Mesa-Tijuana 230 kV transmission line open-ended at Tijuana in CFE's territory due to underfrequency protection.⁵⁵ Less than a second later, at 15:38:23.13, the Imperial Valley-La Rosita 230 kV transmission line open-ended at Imperial Valley in SDG&E's territory by underfrequency protection.⁵⁶ According to CFE, its UFLS program was not designed for the operation of a SDG&E/CFE/Yuma island, but for the operation of a "southern WECC island."

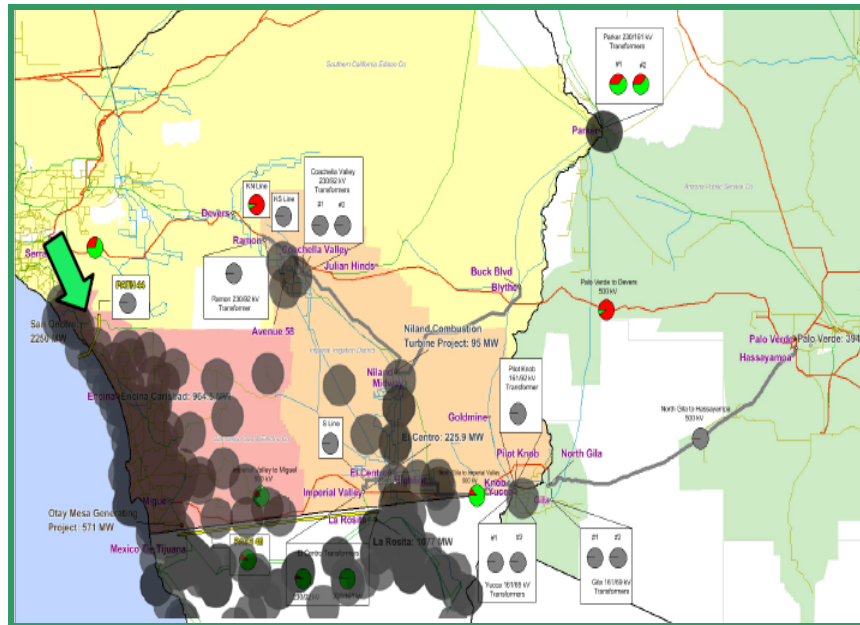
Time: 15:38:30 – The South of SONGS Separation Scheme operates and both SONGS units tripped. (300)

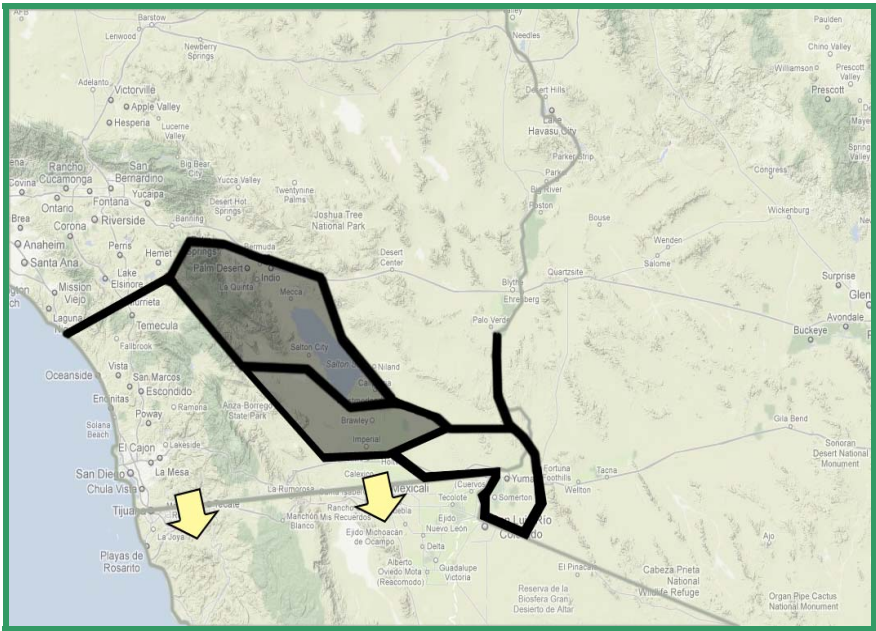
Yuma Separates (Time: 15.38.23.12)

The Yuma island separated from SDG&E at 15:38:23.12, when the Imperial Valley-North Gila 500 kV transmission line tripped by underfrequency protection. APS's UFLS operated on 26 out of the 28 feeders in the Yuma area prior to the loss of the local Yucca steam generators that were on line. However, there was insufficient local generation to stabilize the load pocket in Yuma. At 15:38:38, the Yuma island internal units tripped on underfrequency protection.

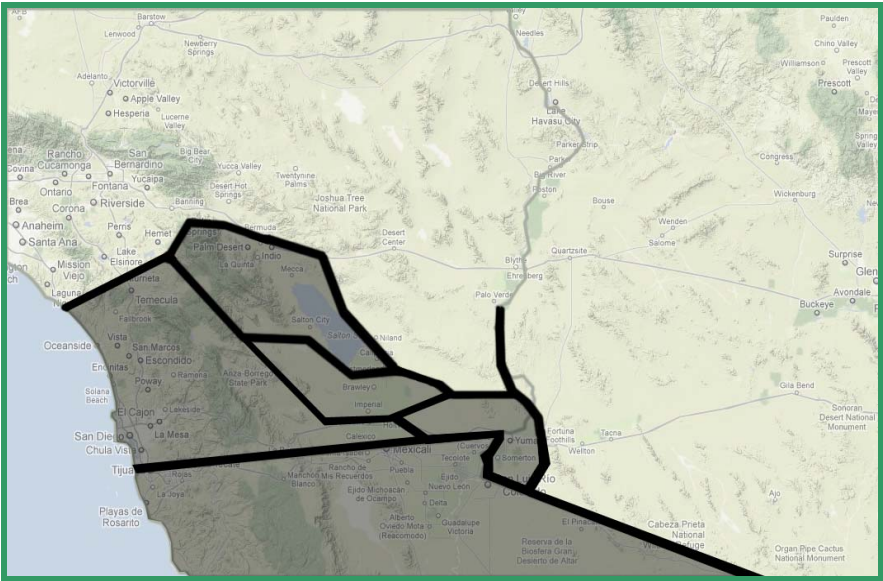
SDG&E, CFE, and Yuma Blackout (by 15.38.30)

By 15:38:38, the SDG&E, CFE and Yuma islands had all collapsed, leaving approximately 2.7 million customers without power.

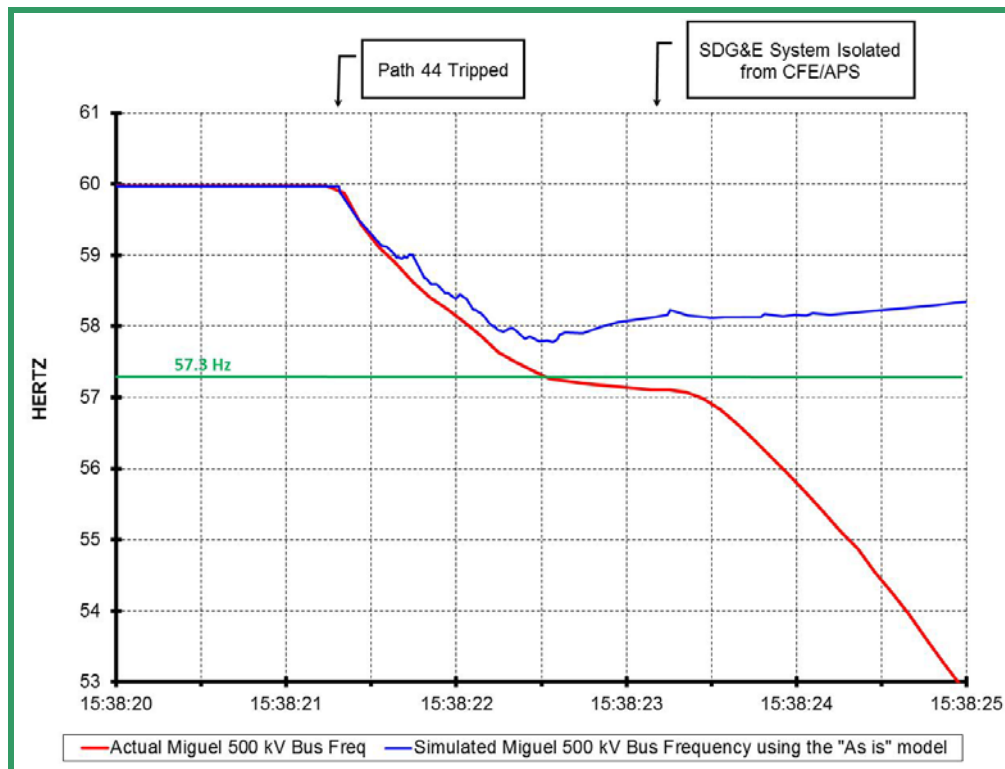
Figure 14: Actual and Simulated Frequency at Miguel 500 kV Bus

The inquiry’s Modeling and Simulation team was able to obtain a simulation more closely aligned with actual measured performance by performing several sensitivity studies and adding details from the actual event, including UFLS performance, PMU

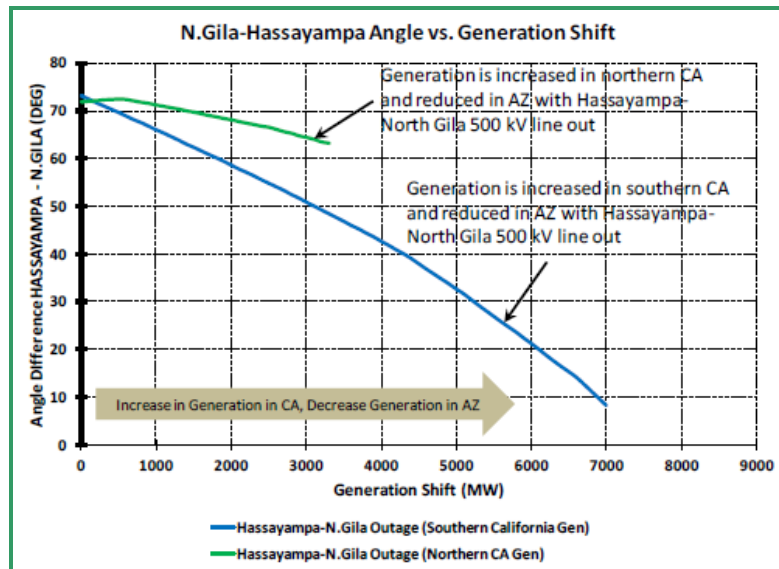
Figure 17: Phase Angle of H-NG vs. Generation Shift

The blue line in Figure 17 illustrates that with the particular conditions of the September 8th event, approximately 1,800 MW needed to be redispatched on both ends of H-NG (and close to the terminals, in Southern California and Arizona) in order to close the voltage phase angle from 72 degrees to 60 degrees (i.e., to within the permissive 60 degree setting of the synchro-check relay). The green line shows that more generation—more than twice as much—must be redispatched if units are chosen in Northern California to close the angle between Hassayampa and North Gila.

While system operators could redispatch generation from available spinning reserves or commit units in the Southern and/or Northern California area, it is questionable how quickly 1,800 MW could be dispatched.
