Arizona-Southern California Outages on September 8, 2011

Causes and Recommendations

Prepared by the Staffs of the
Federal Energy Regulatory Commission
and the
North American Electric Reliability Corporation

April 2012

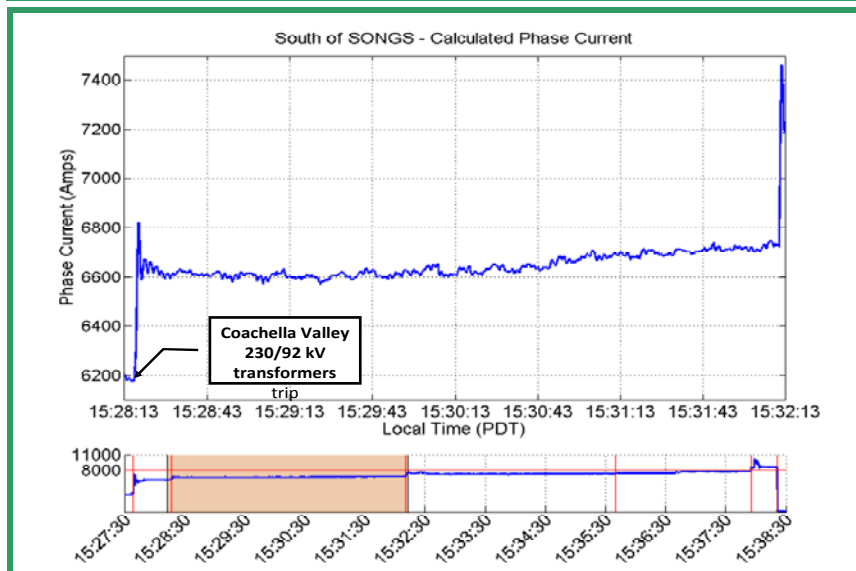
South of SONGS – Calculated Phase Current

15:28:17 – Two Coachella Valley 230/92 kV transformers and the Coachella Valley Ramon 230 kV “KS” line tripped. (030)

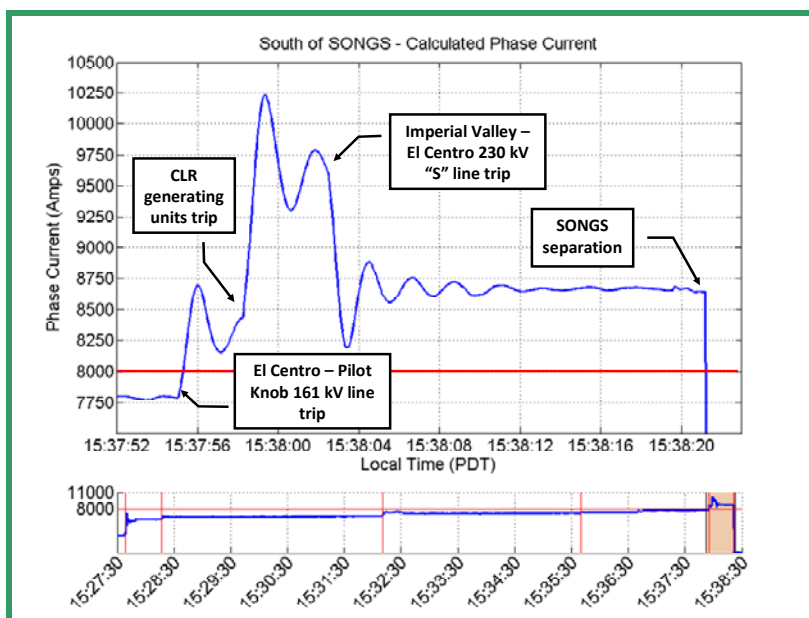
South of SONGS – Calculated Phase Current

Time: 15:37:55 – The El Centro-Pilot Knob 161 kV line tripped. (230)
